Preliminary Observations and Recommendations for Implementation of Postharvest Best Practices

June, 2013

Shay Zeltzer, Postharvest Hub

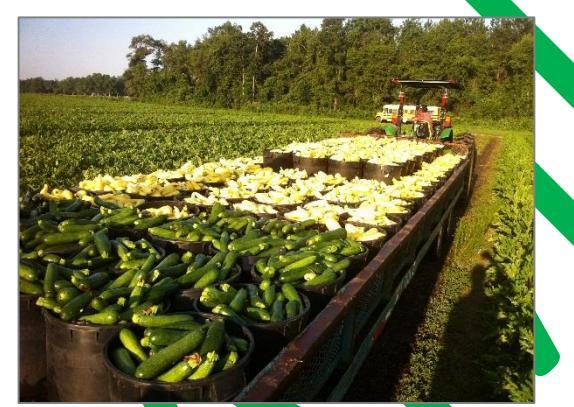
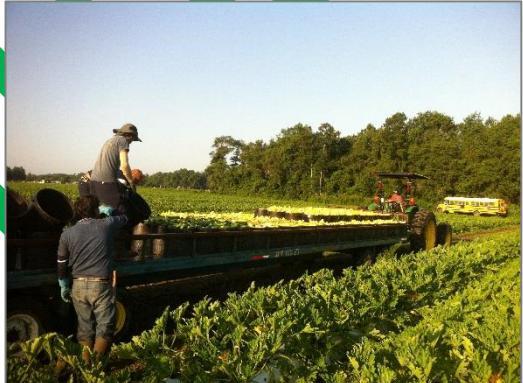
Fig 1: Produce hulling platforms

- 3) It takes a minimum of three hours from the time that picking is started until the full platform is delivered to the packing shed. During the entire time the produce is exposed to direct sunlight resulting in dehydration and heat buildup, thus ultimate freshness is compromised.

- 4) Upon arrival at the packing shed, the bins are piled and await processing on the washing /sorting/ packing line. At that time the produce is likely kept under roof, however the duration of the time until it is processed is not monitored and produce may be left over night before it is processed, packed and cooled resulting in further comprised shelf life.

Cut to Cool time should be monitored and goal should be set for this to be minimized.

While in the field, the produce that is on the platform should be covered with reflective shade net, XX or equivalent, to protect the produce from direct sun light.

3. Produce must be processed within limited time after it's been picked and should never be left overnight in the bins of buckets.

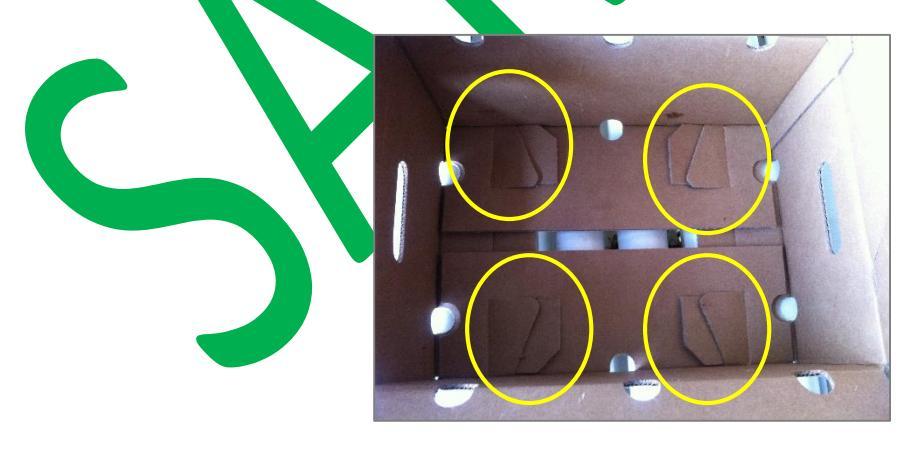
Cartons all are hand assembled and have rough bottoms with the lock-tabs sticking out damaging the delicate skin of the produce (mainly squash, eggplants and cucumbers).

Fig 3a: locking tabs sticks in on the bottom of the carton, hurting the delicate skin of the squash, eggplants and cucumbers.

- 4. Palletizing patterns should be decided upon and adhered to, including the use of corner boards on all pallets and pallet straps instead of adhesive tape. The position of the straps should be specified and followed.
- 5. For the produce items marketed by XXX the most suitable carton would have a smooth flat bottom. Ideally this would be machine erected cartons for efficiency and alterngth purposes.

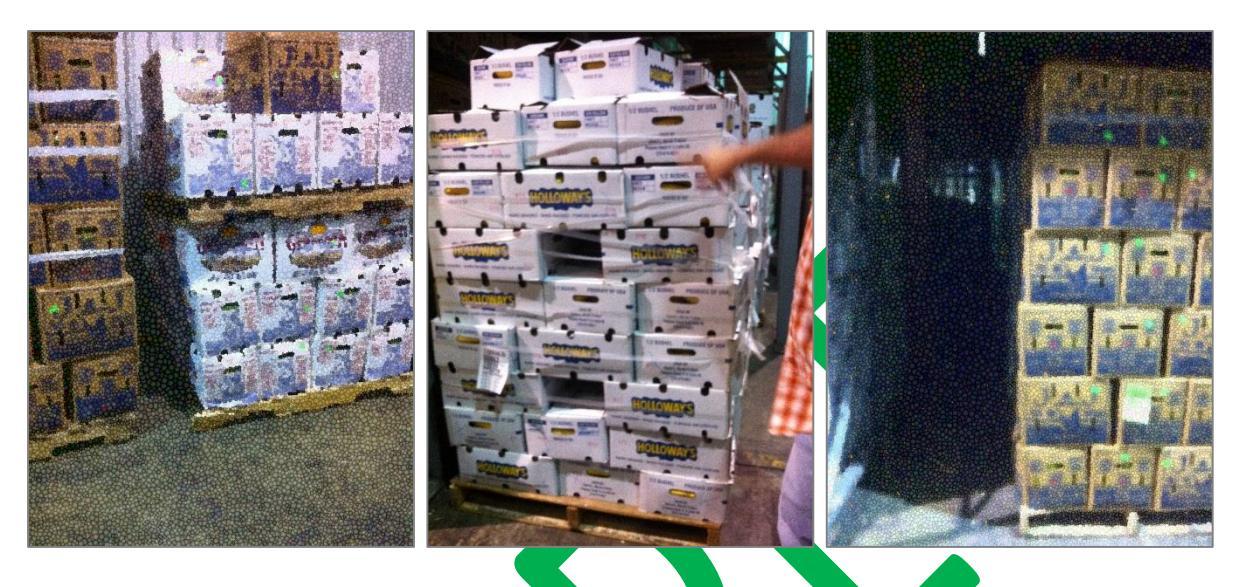
Cross-lock stacking pattern is commonly used and many pallets found leaning and cartons bulged and collapsed.

Fig 3b: Cross-lock stacking pattern, pallets leaning and cartons bulges out and collapse.

- 1. A branded pallet of produce should be perfectly aligned, strapped and solid. This configuration also assure that the produce within is properly supported so that mechanical damage (compression) is avoided.
- 2. Since carton strength is at the corners and therefore there is no other proper option than column stacking or else the carton will, sooner or later, collapse. The carton foot print should be designed so that it is optimal for the pack style sold and utilize the entire area of the pallet. Ideal layouts support 6, 8 and 10 down, symmetric stacking pattern.
- 3. Carton strength should be defined with the carton suppliers based on the load (weight, distance, transportation method and storage conditions) it is subjected to. The carton supplier should be

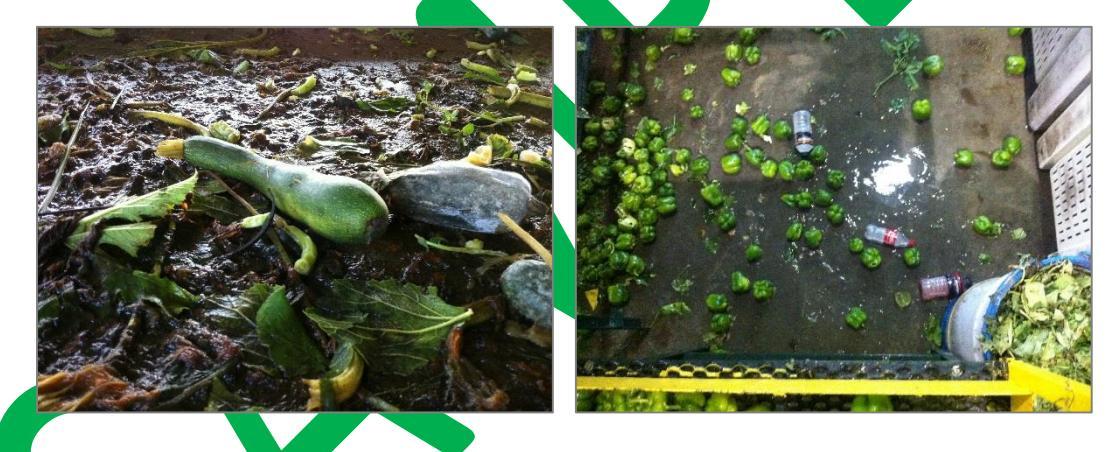
Fig 4a: Decay, rotten produce and organic matter remains on the washing/packing lines (left) and food/drink packaging alongside fruit and waste is all over the floor.

2. The entire facility should be sanitized daily. Dedicated labor and time should be made available for that. No culls and produce waste should remain at the premises and the surrounding area.

Eating, drinking, smoking and chewing gums is prohibited except for designated areas.

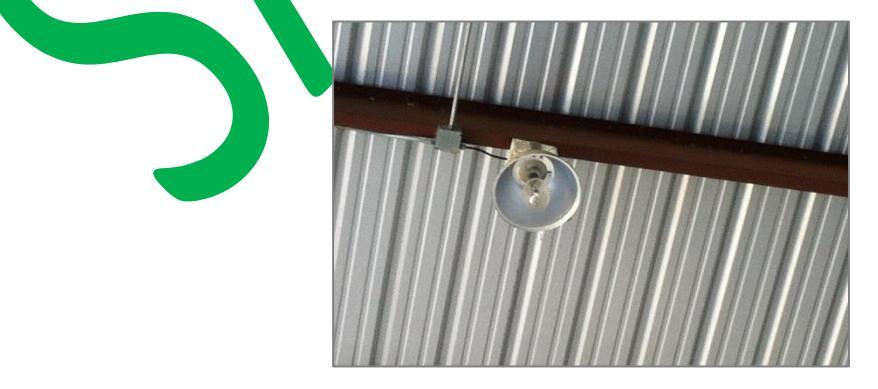
Fig 4b: Light bulbs are not protected.

1. Food safety protocol should be installed and enforced. Ideally Global G.A.P and HACCP accreditations are ackleved.

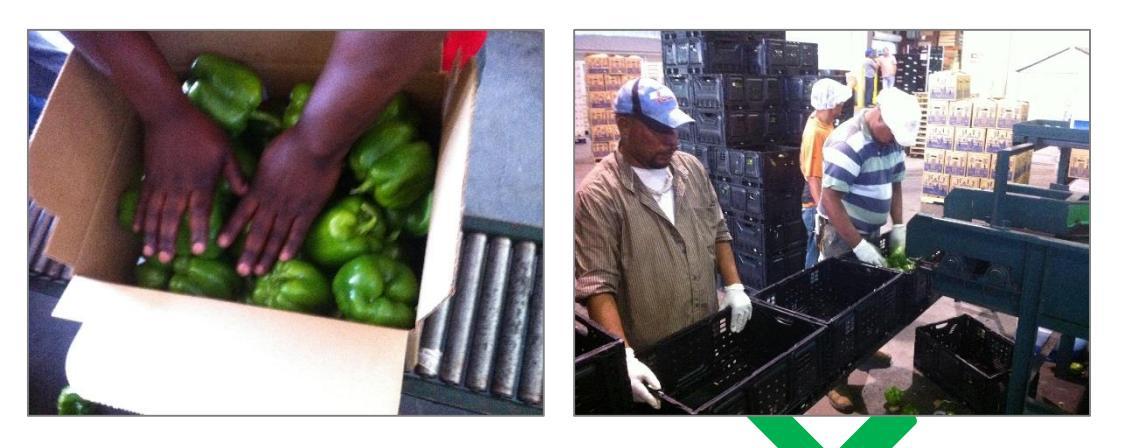
Fig 4c: No hair net, apron and gloves policy is enforced.

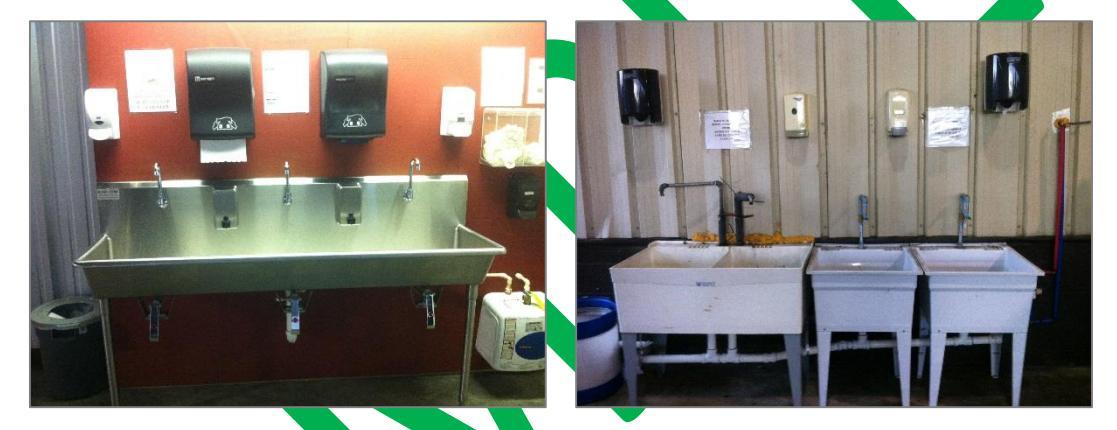
Fig 4e: Washing station at XXX (left) should be used as an example for good installation. Soap and paper dispensers are beyond reach at the central packing shed (right).

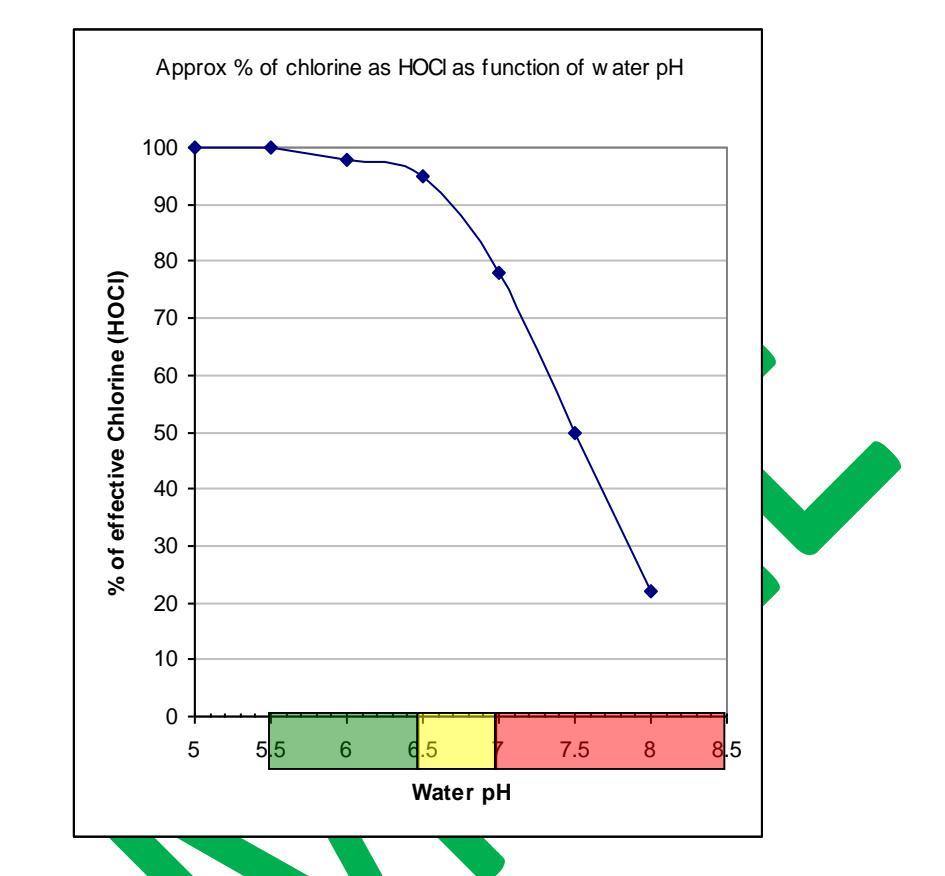
Chart 1: Influence of pH on the proportions of the active chlorine (HOCI) in water

- a. XXX, 60-800pm. Supplied by XXXX
- b. Stabilized applied chlorine tablets / powder. XXXX supplied by XXXX
- c. Chlorine r Acid by various suppliers. The chlorine concentration used for disinfecting purposes needs to be increased to 100-150 ppm and the pH reduced and maintained at pH 6.0-6.5 for efficient sanitation. As shown in Chart 1 below, an increase of the pH above 7 results in significant decrease in the amount of the effective Chlorine acting form (HOCI). In order to achieve it Citric Acid, Phosphoric acid or Hydrochloric (HCI) is commonly used. It is important to always have the pre wash tub maintained with ORP which is higher than 650mV.

- d. It is recommended that ORP meters as well as pH meter are purchased and that water chemistry is checked once an hour, data is recorded and corrective actions are taken when necessary. It is better yet to have an automatic system that administer the sanitizers and maintain the recommended working dosage automatically.
 e. Recommended QC devices: ORN probe for example 'pH and ORP tester combo
 - (http://www.hamaunst.com/products/prodline/newProd.cfm?ProdCode=HI%2098121)

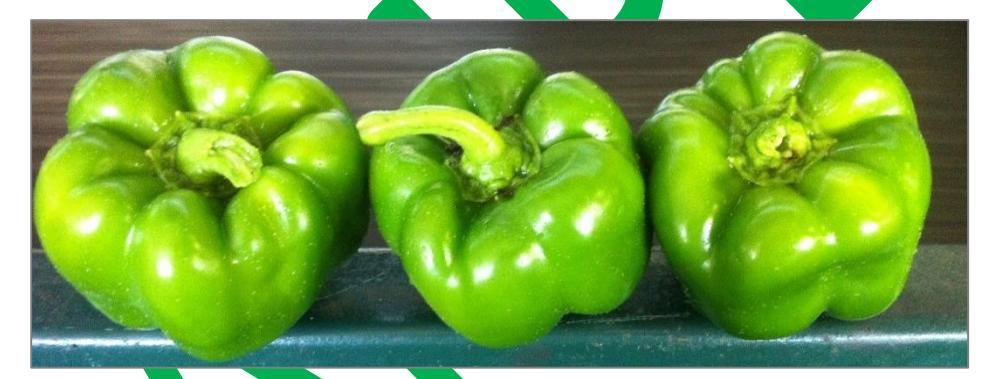
When bell pepper is pulled off the plant using current practice it results in severe injury to the calyx. There were peppers with the calyx completely removed all the way to the sepals, others were broken in half and yet others where the calyx is intact to the knuckle and beyond. Unfortunately, this is a common practice.

Fig 5a: various calyx cut. Ripping the calyx off (right) or breaking the calyx (left) leaving severely injured tissue that is likely to develop decay over time.

- 1. Whatever the specification is established, the stem must be cut using sharp clippers that are routinely sanitized. This is to minimize the size of the wound and avoid contamination and decay.
- 2. The bell peppers lines should be looked at and the following should be fixed:
 - a. Sharp objects and rough surfaces that might bruise the product.
 - b. High drops should be leveled (metal work) so that there is no drop that is higher than 4". These should be than padded using soft and washable material.
 - c. Access organic material (leaves and stems) should be left in the field and not be brought to the packing line. Those that still make it to the line should be removed constantly.
 - d. Traps where the peppers get caught and accumulate or loopholes where peppers are thrown off the line should be fixed.

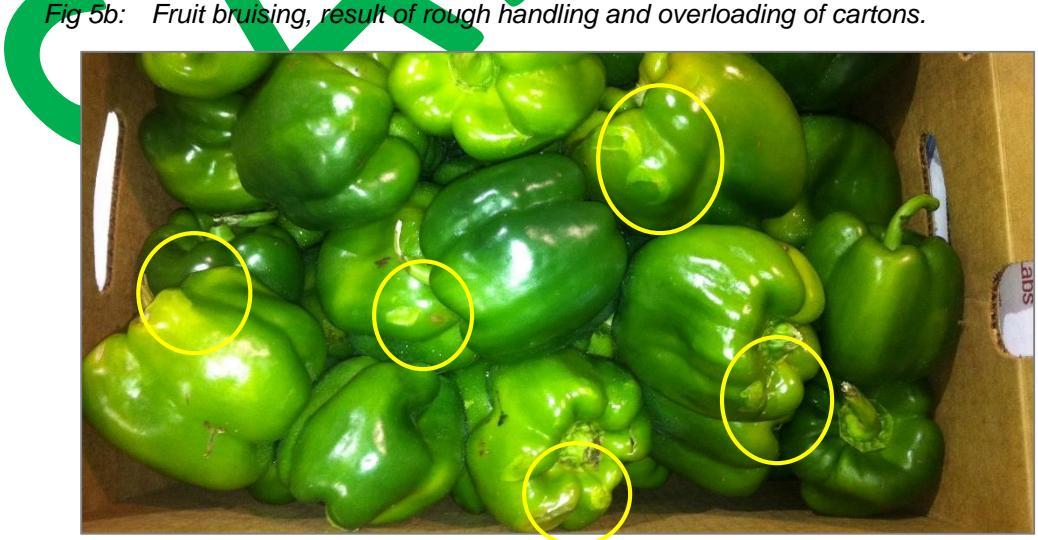
Fruit bruising, result of rough handling and overloading of cartons.

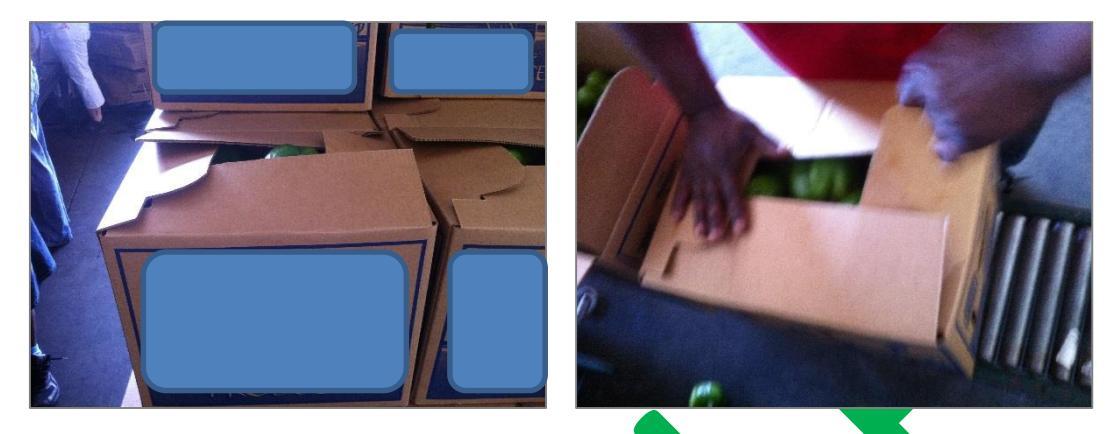
Another common practice is to overload the cartons thus when stacked on one another a pressure is applied to the fruit causing bruising which later manifest itself throughout the supply chain creating waste and loss of sales, rejections or price adjustments. .

Fig 5c: Overly loaded cartons.

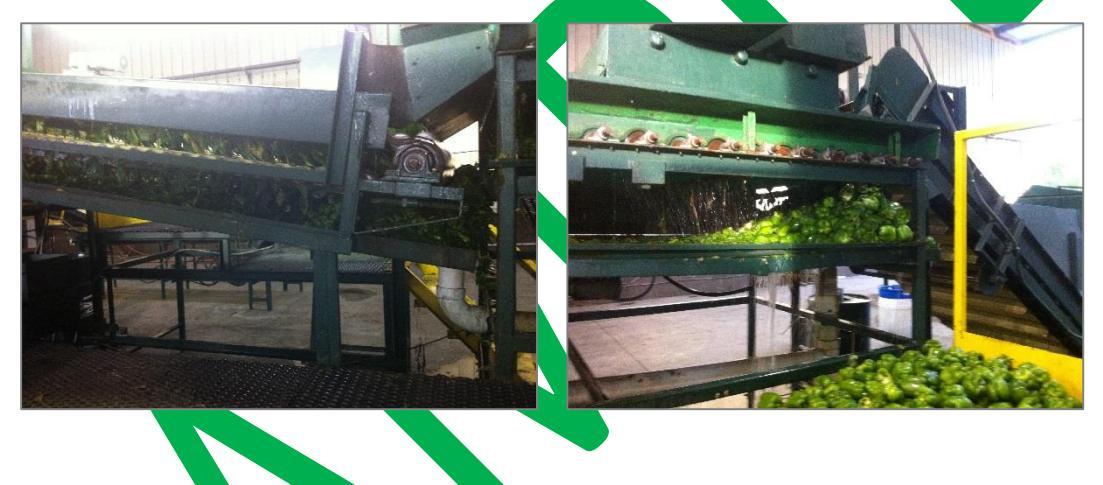
Fig 5d: Ample organic material is compacted on the sorting line (left) and a lot of fruit is falling on the floor (right).

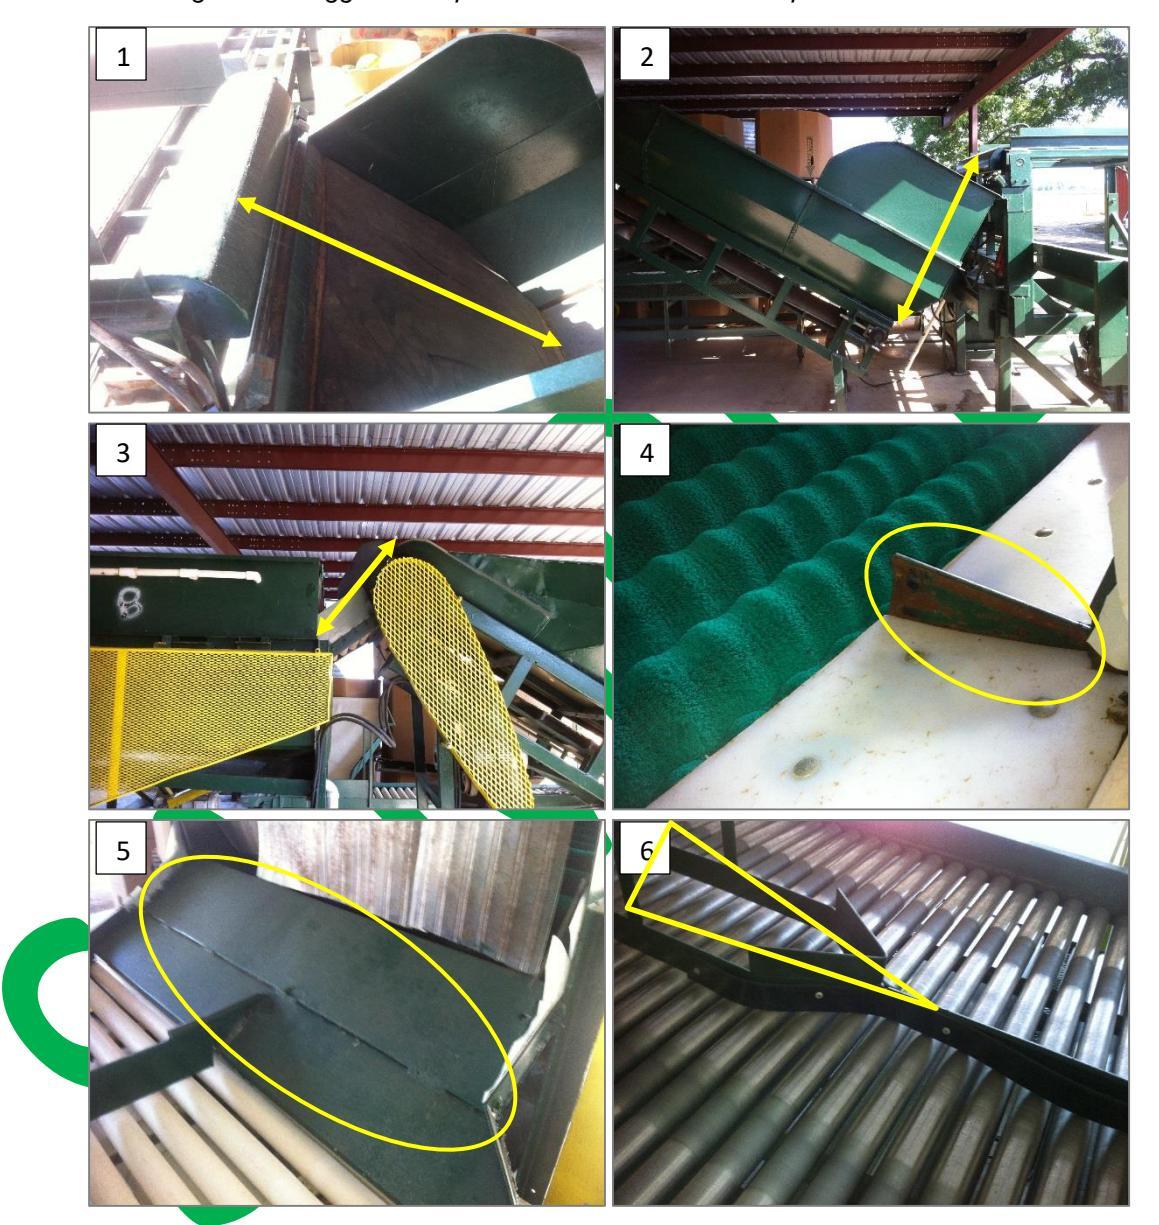
At XXX, the bell pepper line was not designed to minimize bruising which results in dropping fruit in several places along the line and in particular where the bins are dumped. The drop is very high and damage to the fruit is unavoidable.

Fig 5e: Bell pepper sorting line deficiencies: (1,2) High drop at the loading station; (3) high drop between elevator and washing cell; (4) rusted rough divider entering the washing cell; (5) rough un-padded surface exiting the washing cell; (6) divider that is prone to cause congestion. Suggested improvement to allow uninterrupted flow is demonstrated.

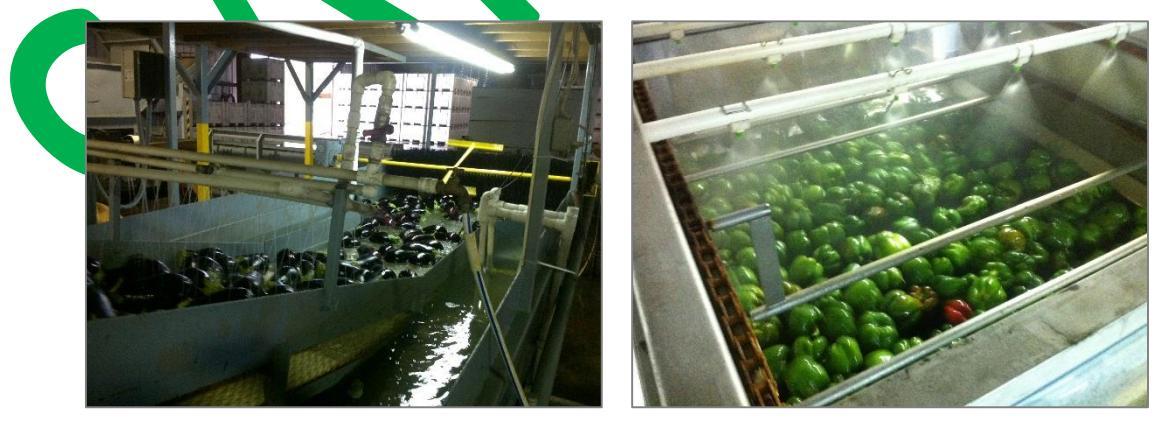
The produce is currently washed using fine sprayers positioned relatively high above the roller brushed or rolls over which the produce is conveyed on. The type of sprayers used can only wet the product but the amount of water administered is not enough to wash it. As a result when fruit exits the washing cell the fruit still carries residues of organic material and debris.

Fig 6: Inadequate rinsing method that's leaves behind considerable residue (spray misters (right) and fine jets (left).

washable, interlock belt should be annexed between the washing station exit conveyor and conveyor belt of the ning line. This would allow excess water to drain as the wet product is rated from the tub and rinsed.

to pursue the option of buying and installing high-capacity, high-airflow, air knifes. This type of air knite should be installed between the water tub and the sorting line so that all excess water will be removed having little to no moisture layer on the fruit's skin. Typical cost per unit can run approximately \$800, Such air-knife could be sourced from XXXX

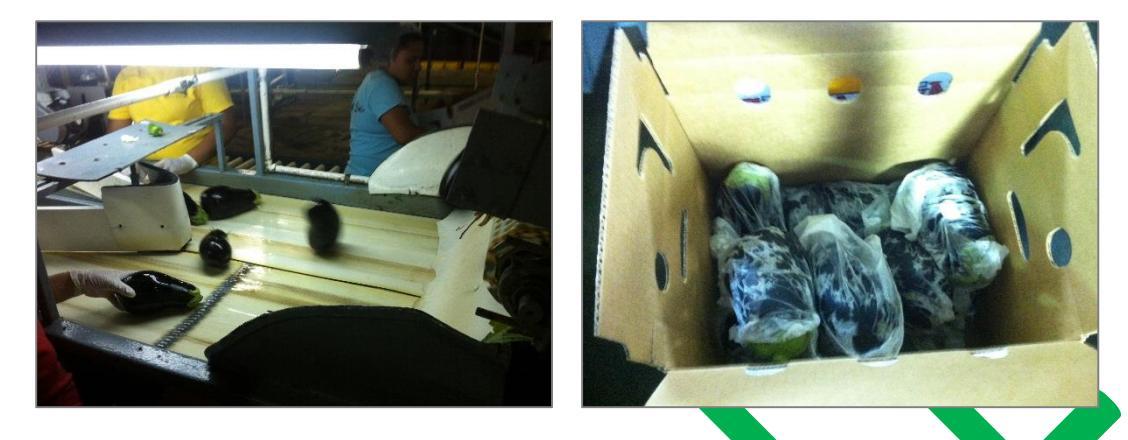
Since no adequate water removal system is installed labor is employed to wipe off the excess water creating bottle neck. Moreover, the fruit remains wet and the stickers often rub off and attach themselves to the conveyor belt.

Fig 7: Wet eggplants is packed into the cartons. Having the fruit packed soaked wet compromised the carton compression resistance.

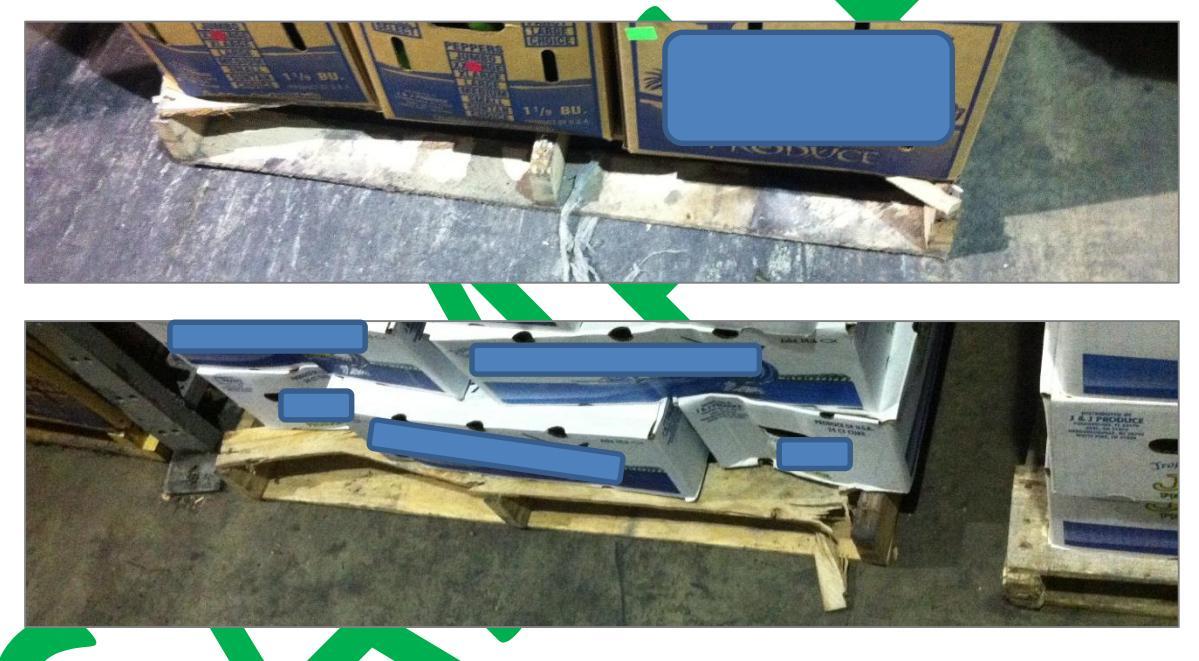
Two types of pallets are used, XXX and wood pallets. While the XXX pallets are produced to spec there is no spec for the wooden pallet and therefore a variety of quality and shapes of pallets could be found. When walking across the cold storage and packing area a lot of broken pallets and poorly constructed pallets were found. The use of the low quality pallet negatively affects the presentation of the unit sold and compromises the quality of the produce within. Pallets that were not built to proper specification presents potential liability for XXX upon arrival at the consumer's location. Sloppy presentation of the units sold calls for closer QC inspection by the receiver risking higher claim and rejection rate for XXX.

Fig 9: Broken wooden pallet and weak wooden pallet compromise the quality of the produce packed and jeopardize the brand.

Whenever pessible invoduce the use of XXX While the pallets are excellent for presentation, sautation doublity etc., a close attention is needed to manage inventory and avoid losing pallets or shipping it out of XXX network or else the monetary consequences could be high.
 A specification for wooden pallets needs to be developed based on fit for use and taking into account receiver needs. A letter of compliance should be provided by each supplier. While materials may vary between countries, the performance of the pallet must be assured. Pallets that do not meet specification would not be used and returned to the supplier. Any compromise should be viewed as a threat to XXX branding effort.

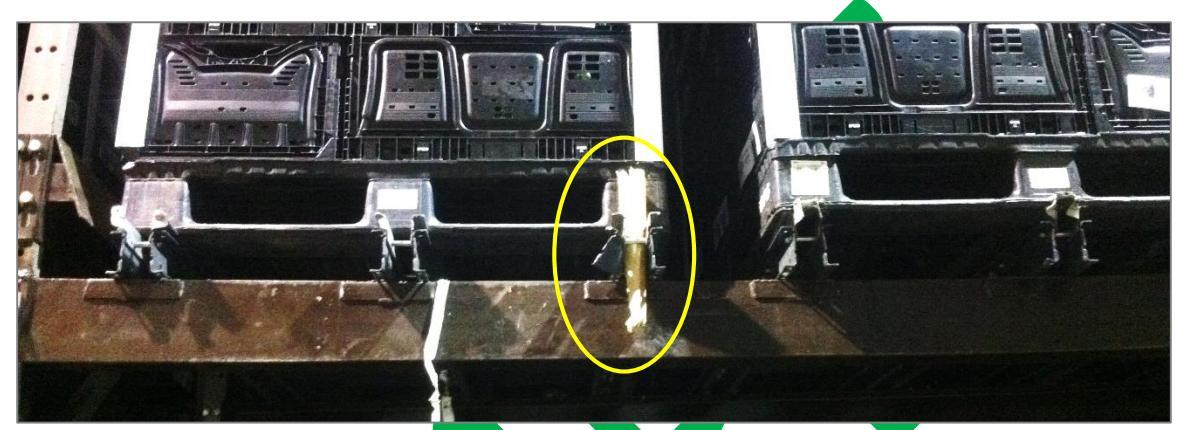
Safety hazard observed with the roller (skate) racks used, inside the cold room, where the pallets on the upper racks tend to slide out of the racks. Broken wood bar is used as a 'stopper' to prevent pallet sliding off of the racks.

Fig 10: Broken wood is used as a 'stopper' on the upper racks.

'L' bar should be installed across the upper racks as a 'stopper' to prevent pellets from sliding off. Install the 'L' bar so that it reaches up to 1x4-1/3 of the void at the bottom part of the pallet to allow for easy access to forklift.

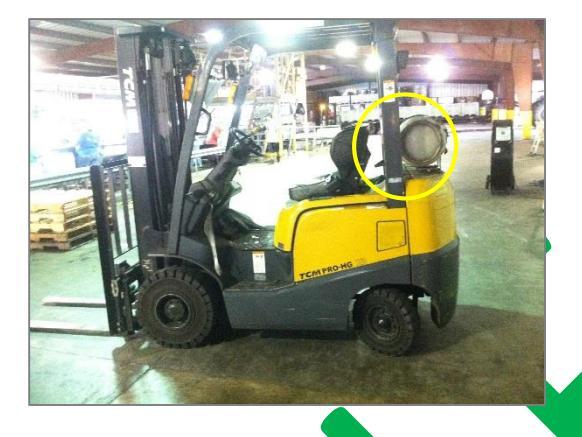
Maneuvering of pallets around is done using forklifts which is cumbersome and increase the risk for accidents and damage in areas that are as dense as they are in this particular distribution center. Moreover, the forklift at Moore farm is gas operated, emitting Ethylene that compromises the condition of the cucumbers and grape tomatoes that are packed in this facility.

Fig 11: Gas operated forklift should not be used in fresh produce operations.

Maneuvering equipment should be electrically

It is suggested to consider replacing the forklifts with electric pallet aches, leaving 1-2 forklift to work inside the cold room on inventory rotation.

wered only.
